## Golden State Mold Inspections

Sample Report  
123 Main St  
Anywhere, Ca 99999

123 Main St  
Anywhere Ca 99999

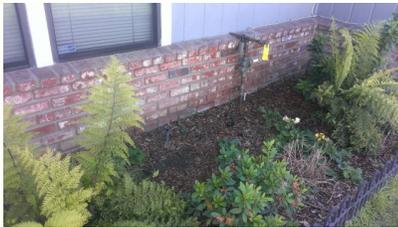
Grounds at the front of the building appear to have inadequate drainage and water may be pooling near or against the exterior wall.

Inspector was informed that sprinklers were spraying on the structure.

**Recommend adjusting sprinklers so that they are not spraying on the structure. Ensuring that drainage is adequate and that water runs away from the structure and does not pool**

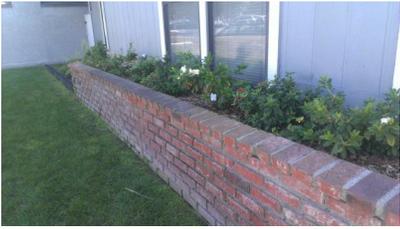
- There are planters close to the structure.

There are planters against the structure at the North and West side. The interior walls opposite of the planters have a high moisture test reading (see Section on Bedrooms) indicating that the planters have a failing or inadequate moisture barrier.

**Recommend digging out the soil in the planters and replace the moisture barrier.**

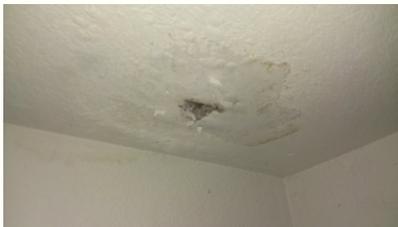
Evidence of a past leak at the ceiling of the cabinet at the Northeast corner (see picture). Moisture test readings were normal at the time of inspection, indicating that the leak is not active.

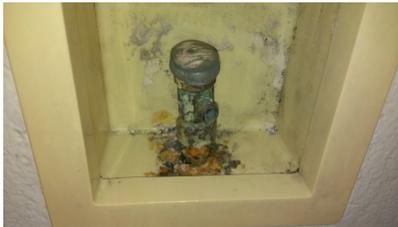
Water line for refrigerator has signs of a past leak. Moisture test readings were normal at the time of inspection.

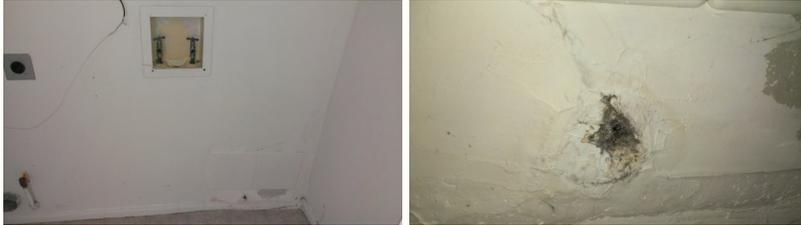
There are signs of microbial growth at the lower portion of the wall (see picture).

There is a high moisture test reading at the wall below the the washer water lines and drain, 30%. It is possible that mold is growing at the interior of the wall where the moisture reading is elevated.

**Recommend surface cleaning per U.S. EPA guidelines, which are available at [www.epa.gov/iaq/molds](http://www.epa.gov/iaq/molds). It is recommended this cleaning be done with an approved microbial inhibitor in all areas mold like substances are present, such as 10%-25% bleach to water solution or other approved biocide.**

**Recommend isolating area, removing dry wall at least 18" beyond high moisture test readings.**

**Note: Further inspection may be necessary once drywall is removed.**

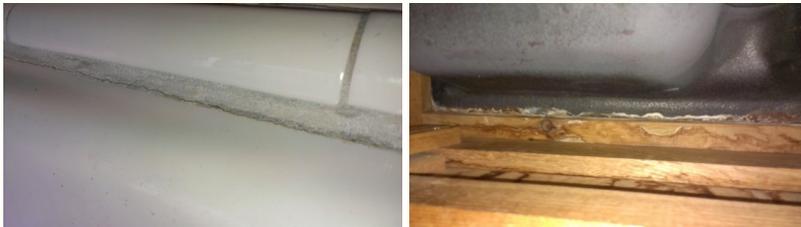
Grout around the sink is cracked. There are signs of moisture intrusion below the sink, through the crack (see pictures).

**Recommend sealing crack.**

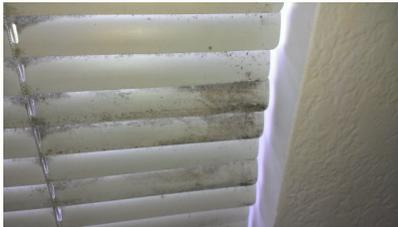
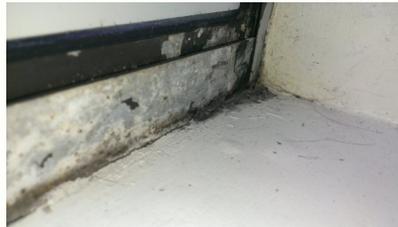
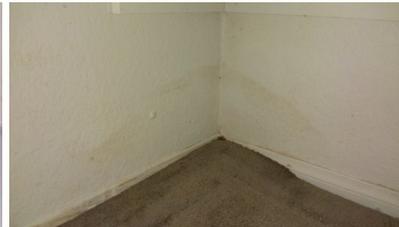
There are signs of microbial growth on the blinds and window sill (see pictures).

There are water stains at the lower portion of the North side of the closet (see picture)

There are high moisture test readings along the lower portion of the North side of the closet, and the lower portion of the North and West walls of the bedroom. High moisture readings are a result of the failing moisture barrier noted in the Section on Soil and Landscaping.

**Isolate bedroom and create a negative air environment.**

**Ensure recommendations noted in Section on Soil and Landscaping are completed.**

**Remove lower portion of the wall at the North side of the closet, North and West walls of the bedroom to at least 18" beyond any high moisture readings and or visible mold growth.**

**Surface clean interior of wall cleaning per U.S. EPA guidelines, which are available at [www.epa.gov/iaq/molds](http://www.epa.gov/iaq/molds). It is recommended this cleaning be done with an approved microbial inhibitor in all areas mold like substances are present, such as 10%-25% bleach to water solution or other approved biocide.**

**Replacing blinds.**

**Surface cleaning window sill per U.S. EPA guidelines, which are available at**

**[www.epa.gov/iaq/molds](http://www.epa.gov/iaq/molds). It is recommended this cleaning be done with an approved microbial inhibitor in all areas mold like substances are present, such as 10%-25% bleach to water solution or other approved biocide.**

**Remove carpet.**

**Obtain mold clearance before replacing materials.**

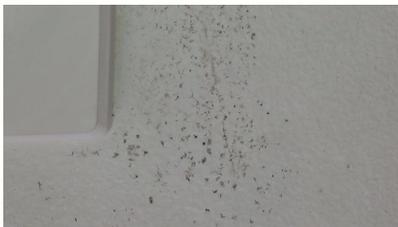
**Comments:**  
There are signs of microbial growth at the ceiling. Mold growth is caused by moisture accumulating on the ceiling.

Poor ventilation. Bathrooms with showers should have a ceiling vent with fan to help circulate and vent the air to prevent moisture from accumulating on the floor, walls and ceiling. This bathroom does not have any additional ventilation which is more than likely the cause of both the microbial growth on the walls and ceiling and the peeling paint.

**Recommend surface cleaning per U.S. EPA guidelines, which are available at [www.epa.gov/iaq/molds](http://www.epa.gov/iaq/molds). It is recommended this cleaning be done with an approved microbial inhibitor in all areas mold like substances are present, such as 10%-25% bleach to water solution or other approved biocide.**

**Recommend ceiling exhaust fan installed.**

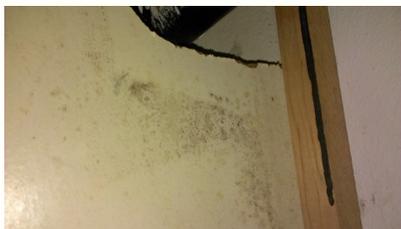
There are signs of microbial growth on the cabinet below the sink (see picture).

High moisture test reading, 17%, at West wall below the sink. This wall is opposite of the exterior planters (see Section on Soil and Landscaping).

**Recommend surface cleaning per U.S. EPA guidelines, which are available at [www.epa.gov/iaq/molds](http://www.epa.gov/iaq/molds). It is recommended this cleaning be done with an approved microbial inhibitor in all areas mold like substances are present, such as 10%-25% bleach to water solution or other approved biocide.**

**Completing recommendations noted in the Soil and Landscaping section.**

**Remove bathroom sink cabinet.**

**Removing drywall were moisture reading is elevated. Surface clean interior of wall per U.S. EPA guidelines, which are available at [www.epa.gov/iaq/molds](http://www.epa.gov/iaq/molds). It is recommended this cleaning be done with an approved microbial inhibitor in all areas mold like substances are present, such as 10%-25% bleach to water solution or other approved biocide.**

**Obtain mold clearance before replacing drywall.**
