## Golden State Mold Inspections

Hans Solo  
5/4/2023

123 Main St.  
Anywhere, CA 98765

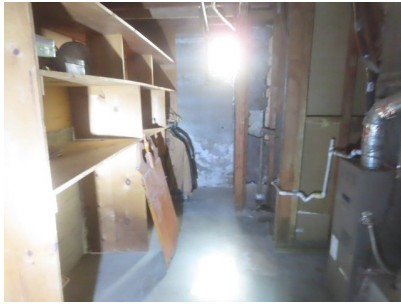
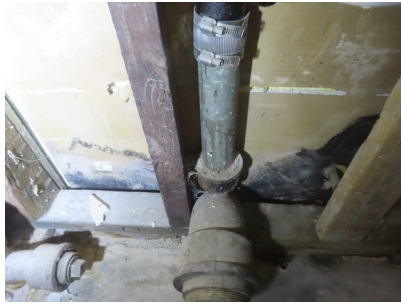
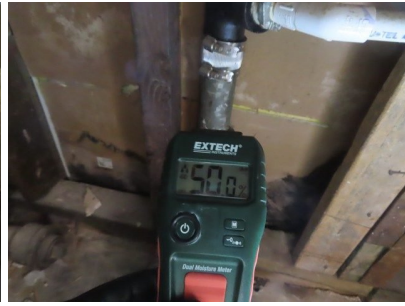
## Basement

There are signs of microbial growth and high moisture test readings at the lower portion of the wall.

**Location:** Basement Wall

**Lab analysis confirms mold growth:**

1. Isolate the area and create a negative air environment.
2. Remove wall coverings to a minimum of 14" beyond any mold growth, water damage and high moisture test readings.
3. Remove any water damaged building materials.
4. Clean surfaces per U.S. EPA guidelines, which are available at [www.epa.gov/iaq/molds](http://www.epa.gov/iaq/molds). It is recommended this cleaning be done with an approved microbial inhibitor in all areas mold like substances are present, such as 10%-25% bleach to water solution or other approved biocide.
5. Allow the area to dry out thoroughly. Use of high powered fans and dehumidifiers may be necessary.
6. Sand wood surfaces as necessary.
7. Run HEPA filter air scrubbers for 48 hours.
8. Obtain mold clearance before removing the containment and replacing materials.
9. Ensure the source of water intrusion is properly repaired.

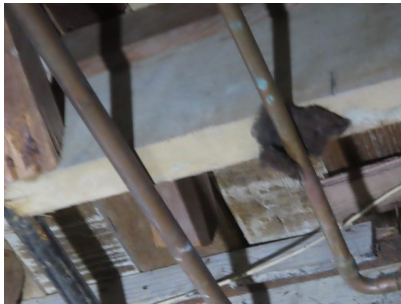
### Water Main & Supply Lines

Copper plumbing noted.

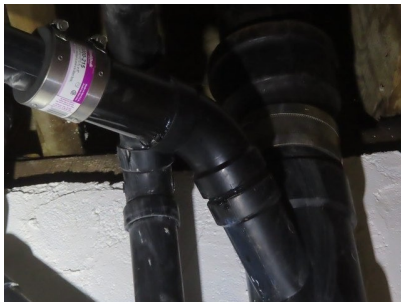
### Waste Pipes

ABS and cast iron waste lines noted.

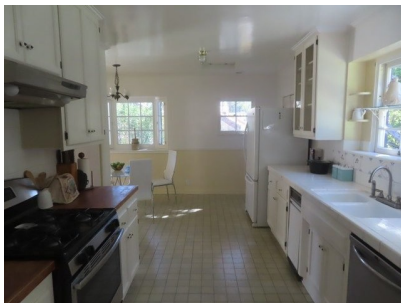
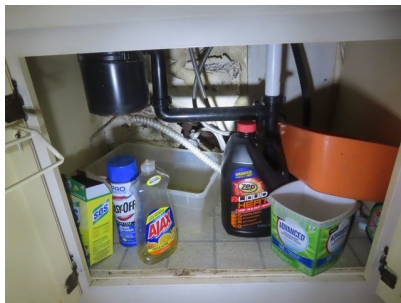
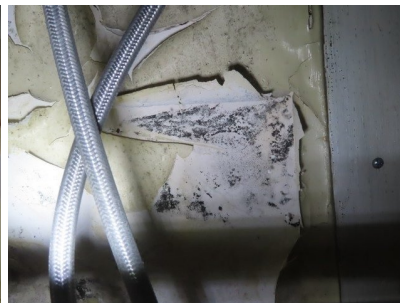
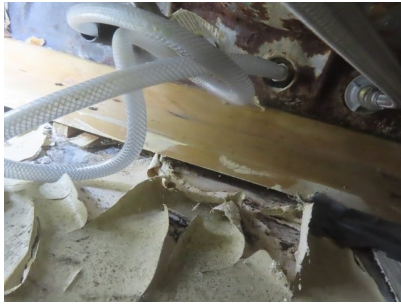
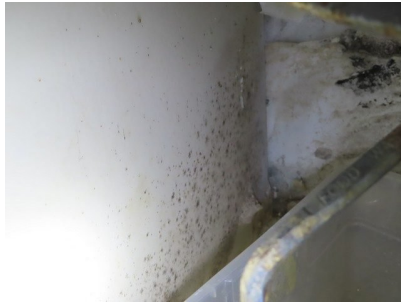
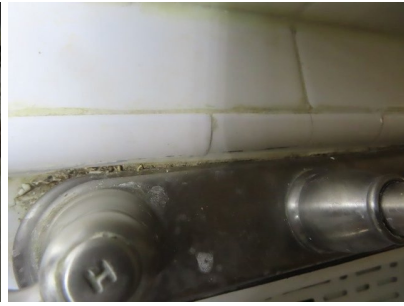
### Kitchen

There are signs of microbial growth at the sink cabinet. A mold swab sample was taken, see section on microbial samples.

The grout is deteriorated at the sink counter.

**Location:** Kitchen Sink Cabinet

**Lab analysis confirms mold growth:**

1. Isolate the area and create a negative air environment.
2. Remove cabinetry and wall coverings to a minimum of 14" beyond any mold growth, water damage and high moisture test readings.
3. Remove any water damaged building materials.
4. Clean surfaces per U.S. EPA guidelines, which are available at [www.epa.gov/iaq/molds](http://www.epa.gov/iaq/molds). It is recommended this cleaning be done with an approved microbial inhibitor in all areas mold like substances are present, such as 10%-25% bleach to water solution or other approved biocide.
5. Allow the area to dry out thoroughly. Use of high powered fans and dehumidifiers may be necessary.
6. Sand wood surfaces as necessary.
7. Run HEPA filter air scrubbers for 48 hours.
8. Obtain mold clearance before removing the containment and replacing materials.
9. Ensure the source of water intrusion is properly repaired.

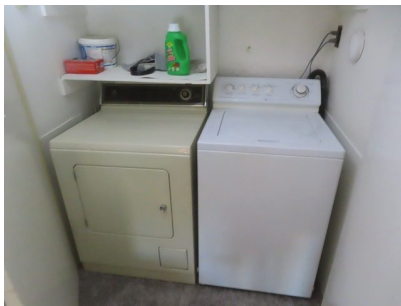
## Laundry Room

- There are obstructions blocking a full view.

Moisture test readings were at normal levels and there were no signs of microbial growth at the time of inspection.

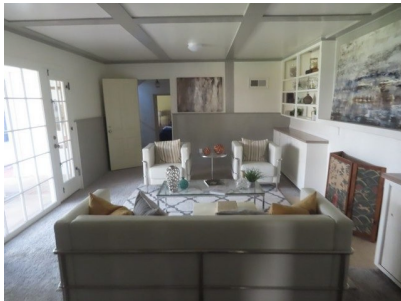
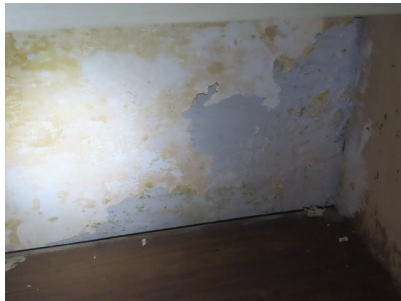
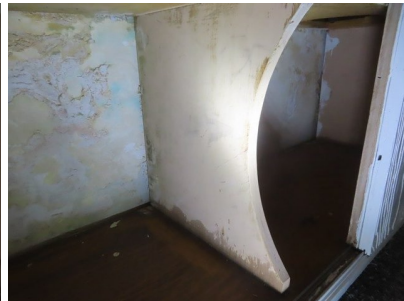
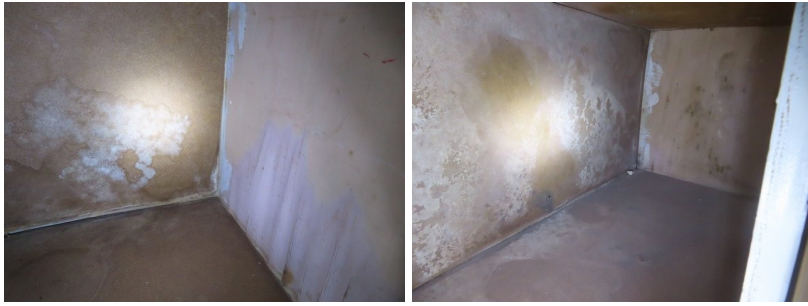
**Room Description:** Living Room

There is a musty odor and signs of microbial growth at the cabinets along the retaining wall.

1. Clean surfaces per U.S. EPA guidelines, which are available at [www.epa.gov/iaq/molds](http://www.epa.gov/iaq/molds). It is recommended this cleaning be done with an approved microbial inhibitor in all areas mold like substances are present, such as 10%-25% bleach to water solution or other approved biocide.
2. Remove cabinets.

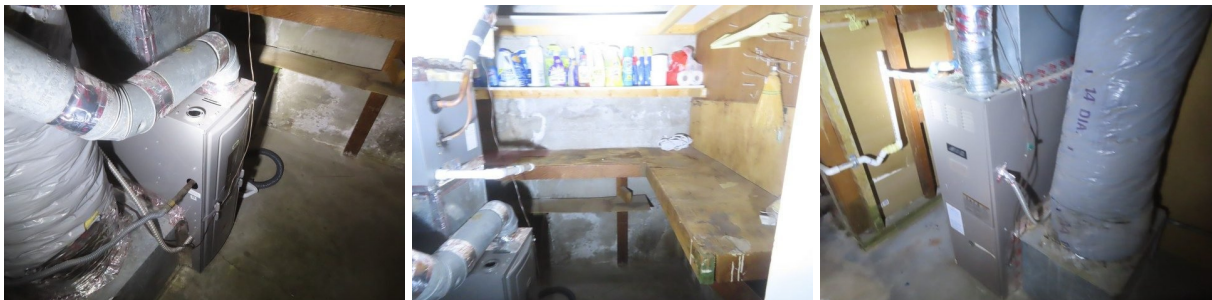
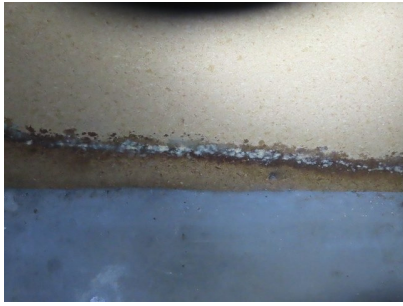
### HVAC Unit

Efflorescence noted at the walls near HVAC unit A.

There are signs of water damage at the lower portion of the wall covering near HVAC unit B.

**Recommend removing wall covering to a minimum of 12" beyond any water damage.**

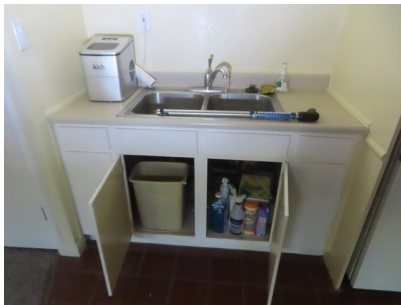
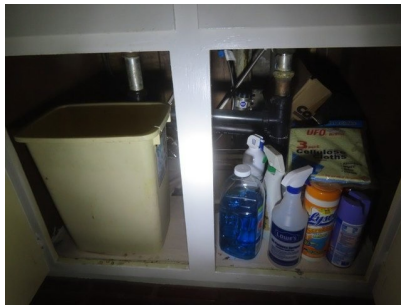
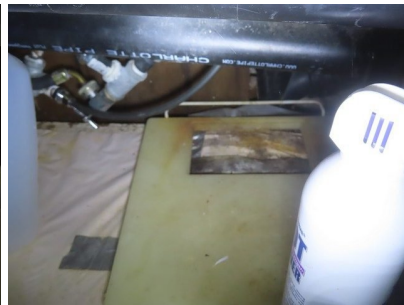
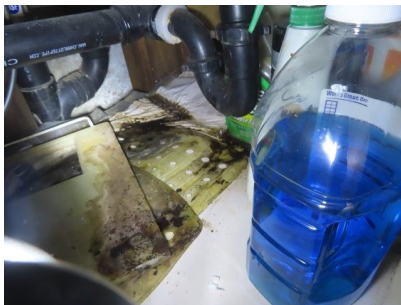
### Sink / Drain

There is an active leak, water damage and standing water at the sink cabinet.

1. Remove sink cabinet bottom and water damaged cabinetry to a minimum of 8" beyond any water damage.
2. Remove any water damaged building materials.
3. Allow the area to dry out thoroughly. Use of high powered fans and dehumidifiers may be necessary.
4. Evaluation by plumbing contractor to ensure proper repair.

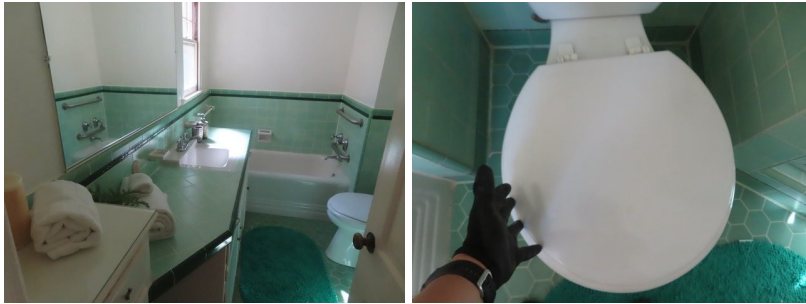
**Room Description:** Upper Bathroom

The toilet is loose at the floor.

**Recommend inspecting the wax ring before properly securing the toilet to the floor.**

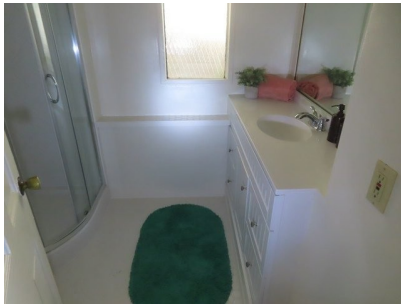
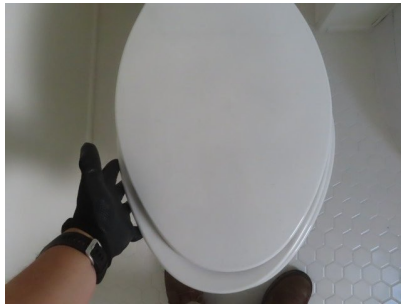
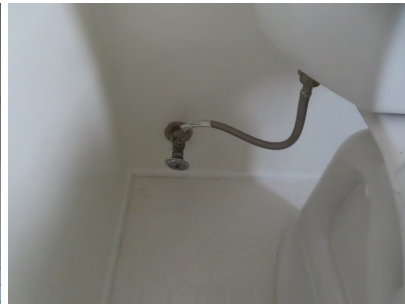
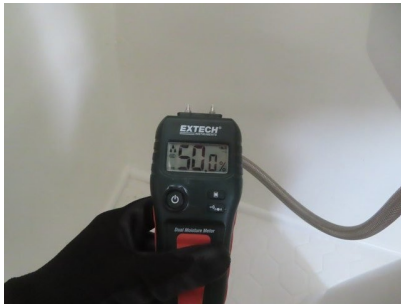
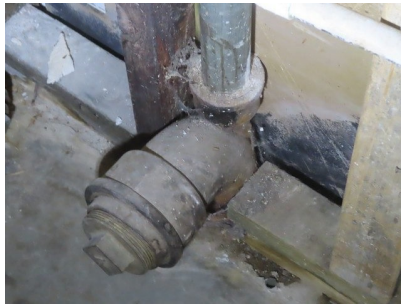
**Room Description:** Lower Bathroom

The toilet is loose at the floor.

There are high moisture test readings at the lower portion of the wall behind the toilet.

There are signs of microbial growth at the lower portion of the wall, observed at the basement (adjacent to the bathroom). A mold swab sample was taken, see sections on Basement and Microbial Samples.

**Recommend inspecting the wax ring before properly securing the toilet to the floor.**

1. Isolate the area and create a negative air environment.
2. Remove wall coverings to a minimum of 14" beyond any mold growth, water damage and high moisture test readings.
3. Remove any water damaged building materials.
4. Clean surfaces per U.S. EPA guidelines, which are available at [www.epa.gov/iaq/molds](http://www.epa.gov/iaq/molds). It is recommended this cleaning be done with an approved microbial inhibitor in all areas mold like substances are present, such as 10%-25% bleach to water solution or other approved biocide.
5. Allow the area to dry out thoroughly. Use of high powered fans and dehumidifiers may be necessary.
6. Sand wood surfaces as necessary.
7. Run HEPA filter air scrubbers for 48 hours.
8. Obtain mold clearance before removing the containment and replacing materials.
9. Ensure the source of water intrusion is properly repaired.
