## Golden State Mold Inspections

ID: Partial Inspection  
123 Main St  
Any, CA 98765

## Interior

### Kitchen

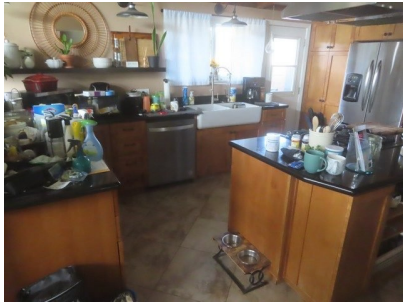
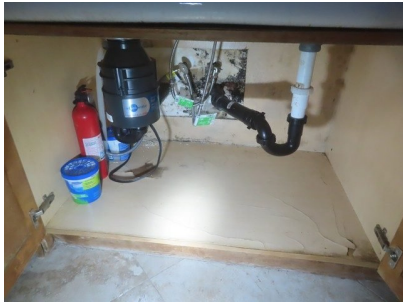
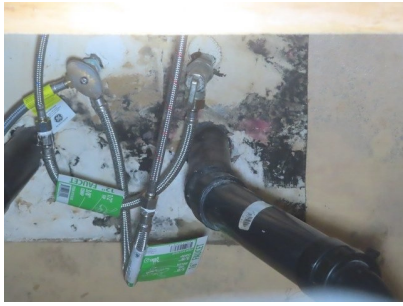
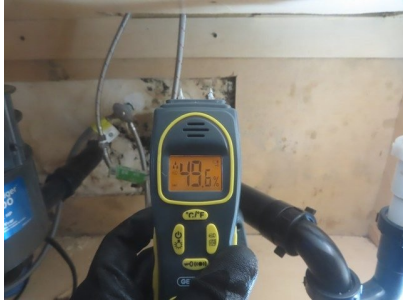
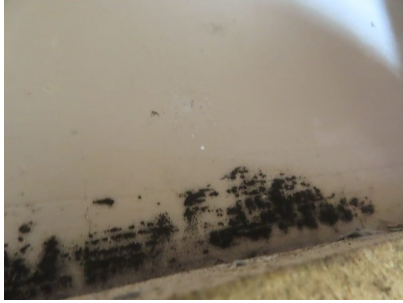
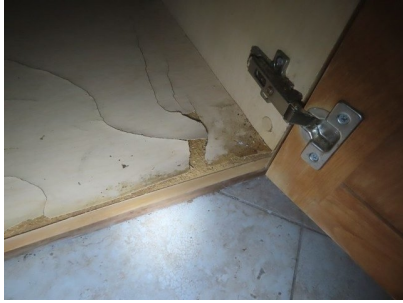
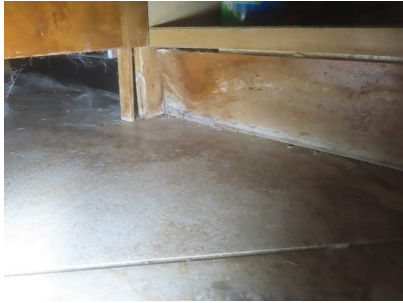
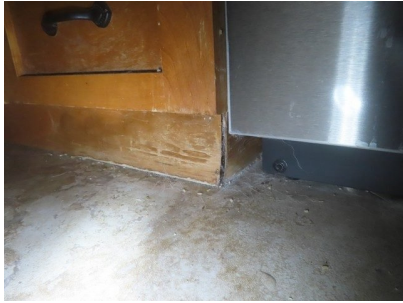
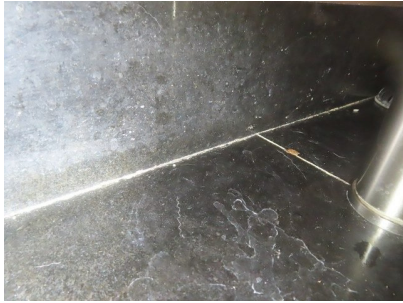
The grout is cracking at the sink counter.

There are signs of microbial growth, water damage and high moisture test readings at the sink cabinet. A mold swab sample was taken, see section on Microbial Samples.

Water damage extends down to the toe kicks.

**Recommend caulking to prevent water intrusion.**

- 1. Isolate the area and create a negative air environment.**
- 2. Remove cabinetry and wall coverings to a minimum of 14" beyond any mold growth, water damage and high moisture test readings.**

- 3. Remove any water damaged building materials.**
- 4. Clean surfaces per U.S. EPA guidelines, which are available at [www.epa.gov/mold](http://www.epa.gov/mold). It is recommended this cleaning be done with an approved microbial inhibitor in all areas mold like substances are present, such as 10%-25% bleach to water solution or other approved biocide.**

- 5. Allow the area to dry out thoroughly. Use of high powered fans and dehumidifiers may be necessary.**
- 6. Sand wood surfaces and encapsulate as necessary.**

- 7. Run HEPA filter air scrubbers for 48 hours.**
- 8. Obtain mold clearance before removing the containment and replacing materials.**
- 9. Ensure the source of water intrusion is properly repaired.**
